The TOUGHEST yet

K. K. Saha, Punj Lloyd Limited, Turkey, reports on the many challenges faced by the company during the grading and clearing of the ROW for the Baku Tbilisi Ceyhan pipeline and how, despite a long history of success in varied and demanding terrain, this experience proved to be one of the toughest.

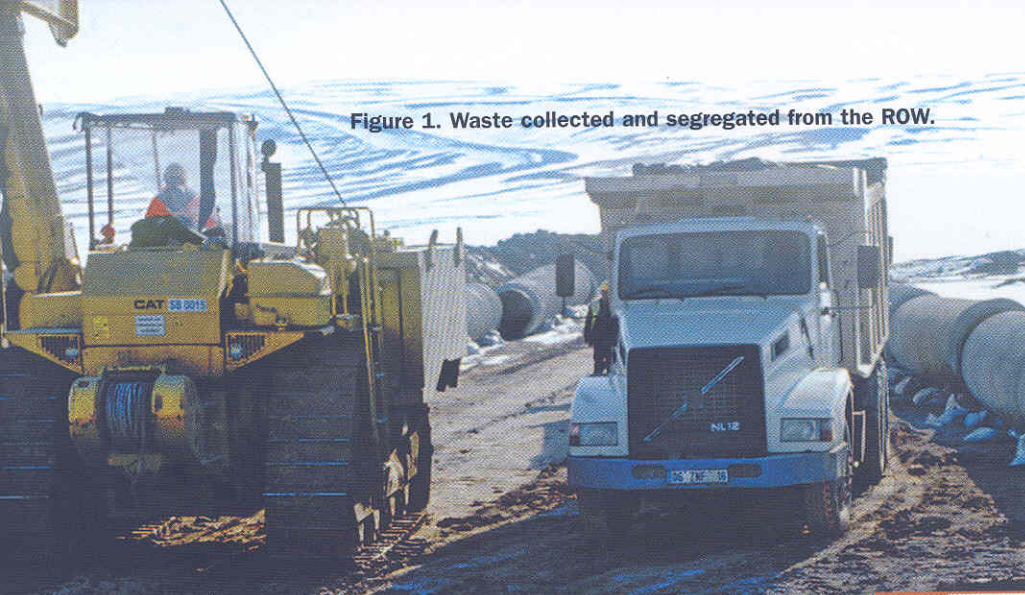
Figure 1. Waste collected and segregated from the ROW.

The removal of unwanted or extra material was carried out according to the agreed procedure and statutory requirements. Necessary permission was taken from the authorities to remove debris from the ROW, transport it and then have it dumped in specified locations.

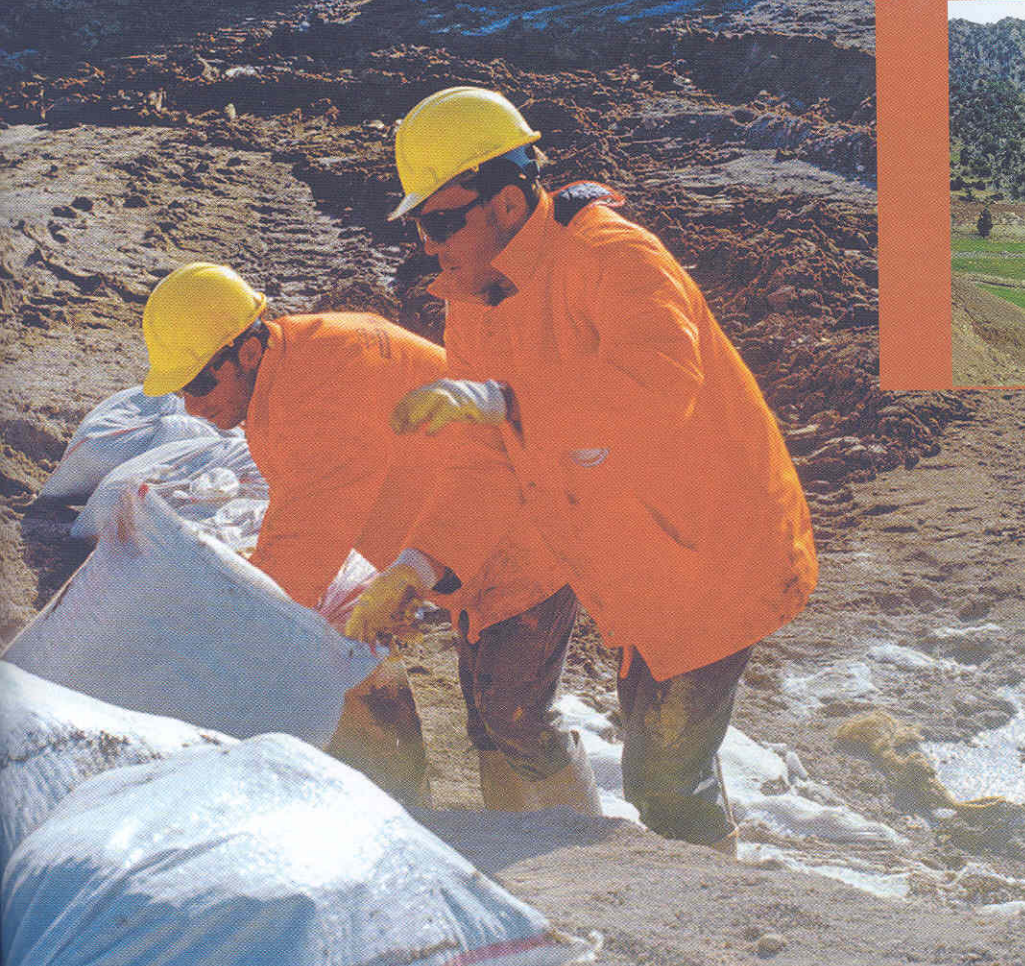
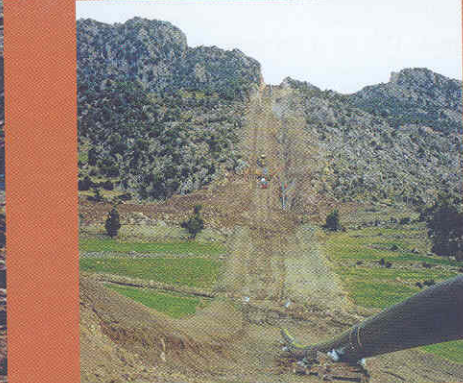
Figure 2. The ROW through the Taurus mountains in Turkey.

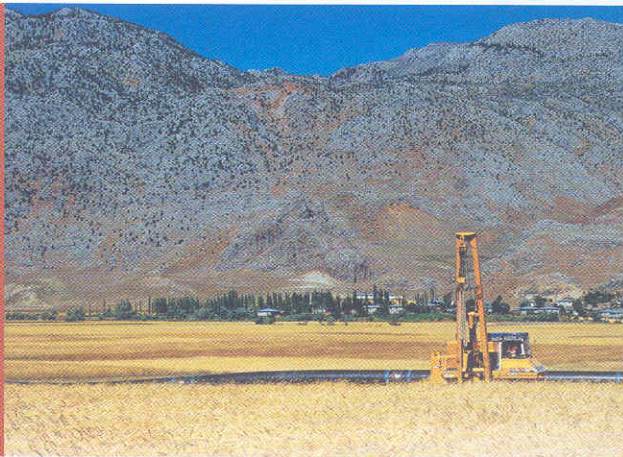
Figure 3. The ROW through agricultural land.

and preserved on one side of the ROW and subsoil on the other side. Depending on the type of terrain and geological characteristics, various methodologies were applied for grading of the ROW. A simple grading operation was carried out by removing and preserving the top soil with the help of graders in agricultural and forest lands. Controlled blasting was carried out by using explosives in rocky areas and rock breakers were employed in rocky, archaeologically sensitive areas. Special grading operations were used in ecologically sensitive areas where topsoil was preserved within geo-textile to keep the seeds and roots of endemic species intact. No grading was carried out in some ecologically sensitive areas where wooden logs were used during construction to reduce the damage to the top soil.

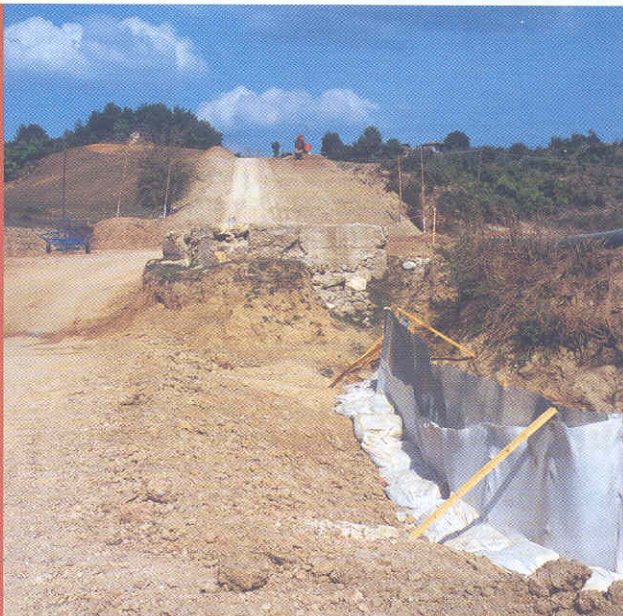
Figure 5. Preservation of top soil with geotextile in ecologically sensitive areas.
